A Historic Building Survey of Skelton Mill, Skelton in Cleveland

Work undertaken by Stephen Sherlock

July 2011

Historic Building Recording at Skelton Mill, Marske Lane, Skelton NZ 649 196

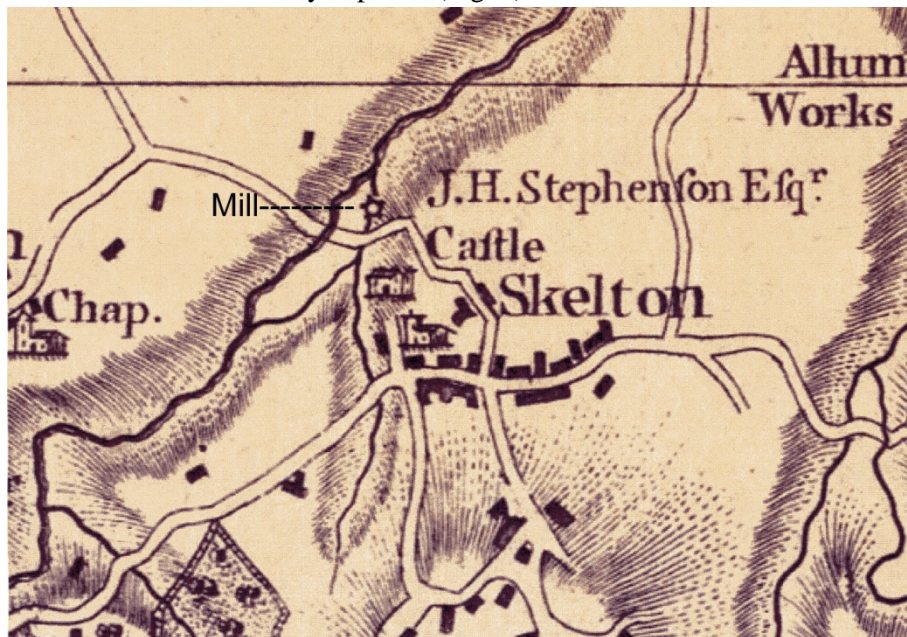
Fig. 2 Jeffreys map of 1773 showing Skelton and the mill.

3.1.1 A map regression exercise was undertaken consulting the Ordnance Survey mapping from 1856 onwards. Seven maps were examined (Appendix 8.2) and the earliest map (1856) does not have the required detail to comment upon the buildings. The next map dated 1895 depicts the mill, mill house and buildings in locations similar to the structures recorded in 2011. The dates of the maps are as follows: 1856, 1895, 1919-1920, 1938-1952, 1958, 1973 and 1994. An earlier map of 1772 by Jeffreys does show the mill to the north of the castle. The site is marked by a waterwheel beside the beck and the mill leat is clearly depicted (Fig. 2).

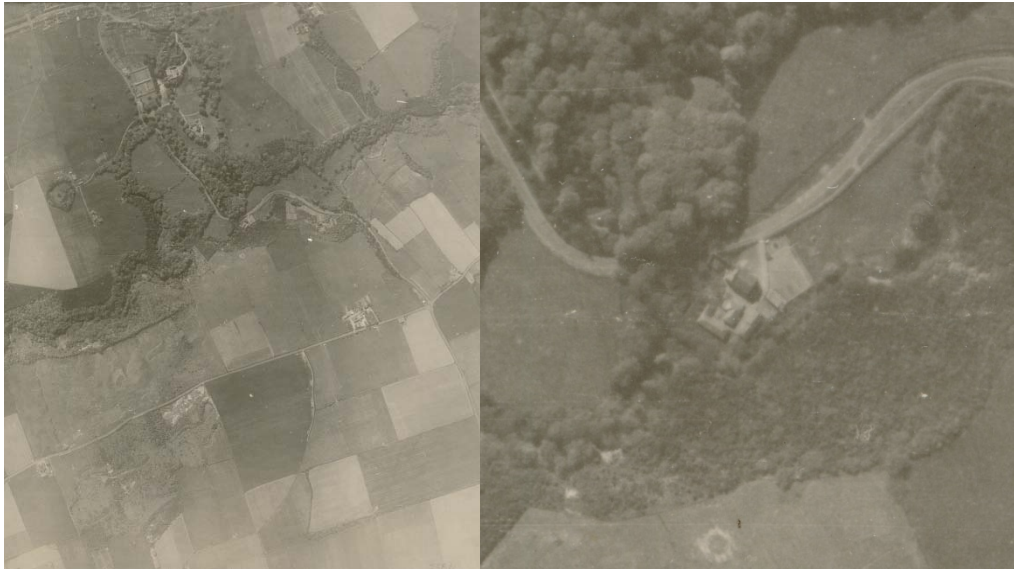
3.1.2 The aerial photographic records were also examined at Tees Archaeology. These included sorties immediately after the war in 1948 and more recent Meridian surveys. The best image from the 1940s is reproduced below (Pl. 1) to show the full image and a detail of the mill.

Pl. 1 RAF photograph of Skelton dated 1948 and a detail of the area of the mill.

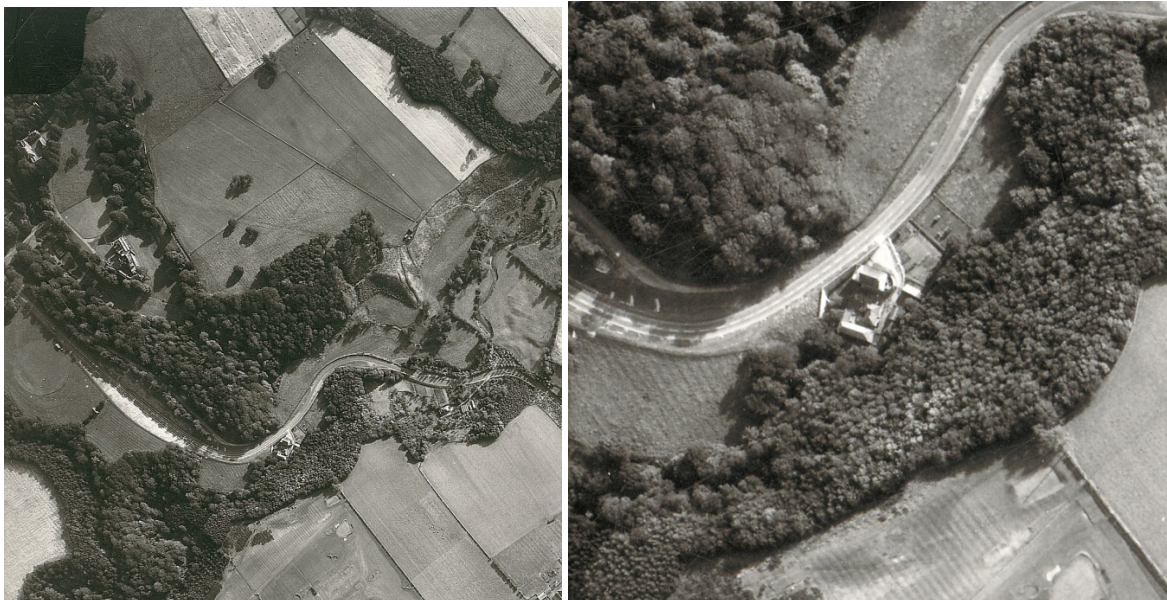
A later Meridian aerial survey of 1965 shows the site after the road was realigned reducing the size of the mill building. This image (Pl. 2) shows the new road, and in more detail the complex of buildings as recorded in 2011 can be seen in the photograph on the right.

Pl. 2 Meridian Aerial photograph 83-65-024 of Skelton Castle (left) and a detail (right) of the mill.

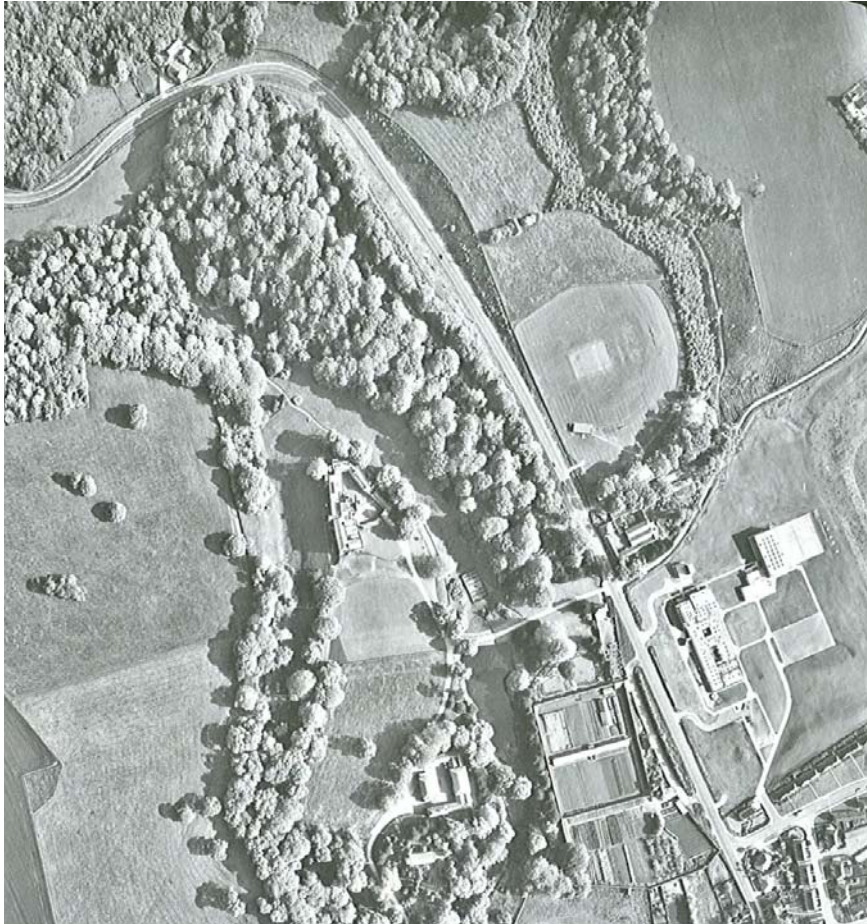
Pl. 3 Aerial Survey of 1981 by BKS for Cleveland County Council (ref no. 3060150 showing Skelton Mill beyond the woods to the north of Skelton Castle, Middlesbrough Library).

This building had a clear perspex corrugated roof and was glazed on the west side. It had a brick base and is thought to have been adapted from an earlier possible greenhouse. It is to the north of the mill house (Fig. 3). The aerial photographs (Pl. 2 and Pl. 3) show a building at this location but it is unclear if it is the present structure. This building had a brick wall on the east and north, a low brick wall glazed above and a sandstone wall on the south. The bricks are laid in a bond of headers after five stretchers, i.e. English garden wall bond. The sandstone blocks on the south side measure 0.50m long and 0.22m high. The interior of the building had been carpeted and cupboards were fitted, although these are made of MDF or similar material and this is thought to date from the last twenty years.

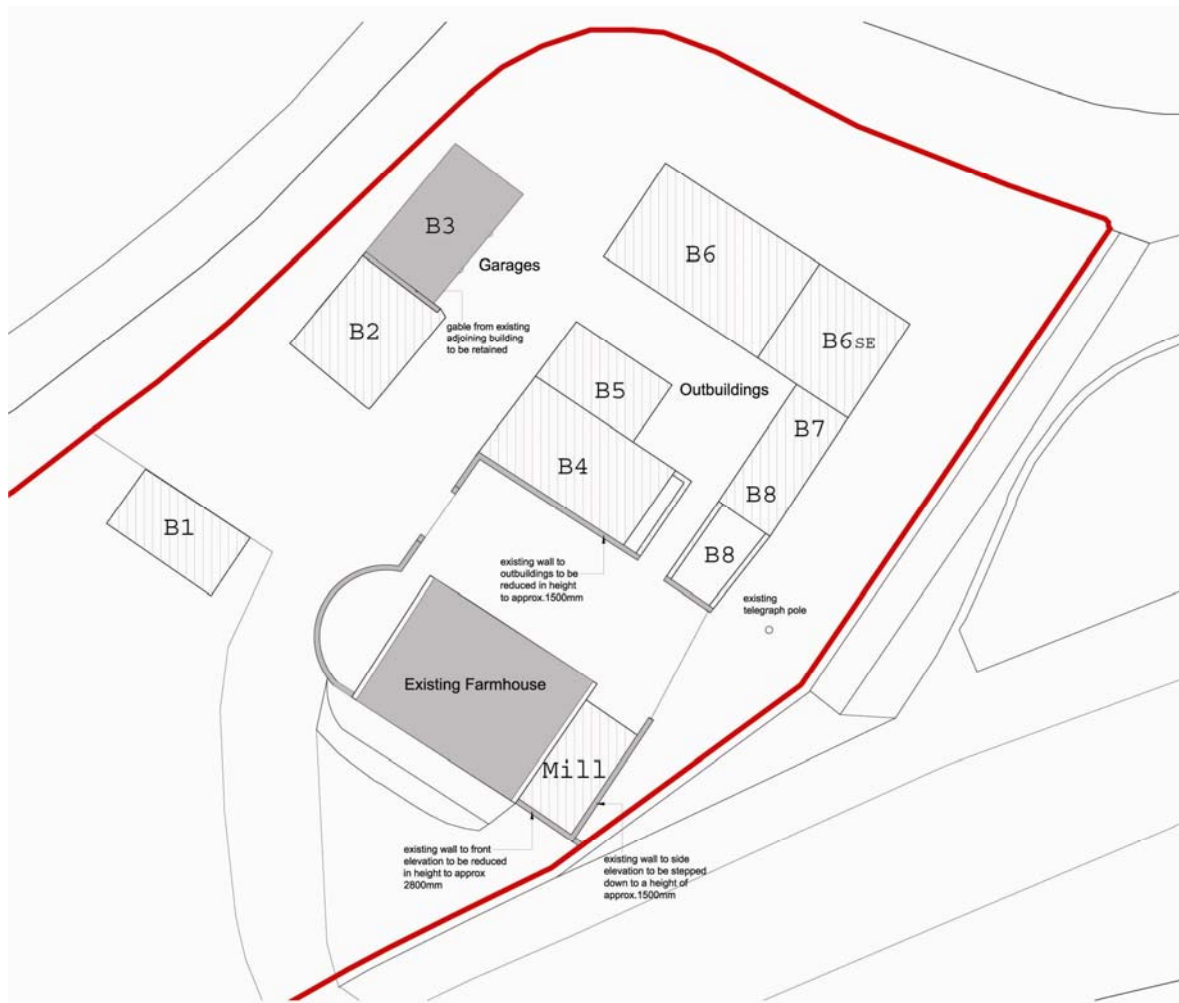
Fig. 3 Plan of site to show the location of the buildings mentioned in the text.

A photographic and measured survey was undertaken as part of the process of recording the buildings. Each building was given a number; photographs in monochrome and digital formats were taken and locations were plotted onto a site plan (Fig. 3). The buildings have been given separate numbers to follow the pattern of their most recent use and the manner in which they are illustrated in the planning application. It will be argued they had a simpler plan originally. Scales were used in all of the images and in addition to elevation images, internal photographs were taken of original features e.g. windows, doors and fireplaces. The buildings will be discussed by the quadrants of the compass and although Building 1 is not truly aligned north-south the elevations will be presented in this manner for ease of discussion.

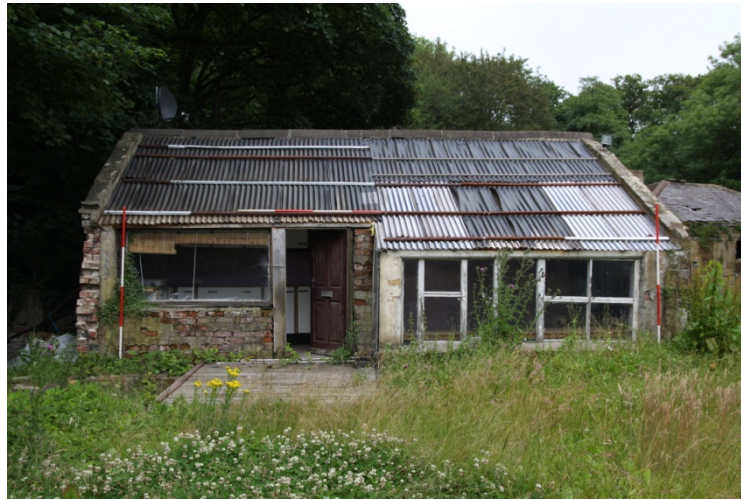
Pl. 4 Image of Building 1 from the west looking east (marked P1 on plan).

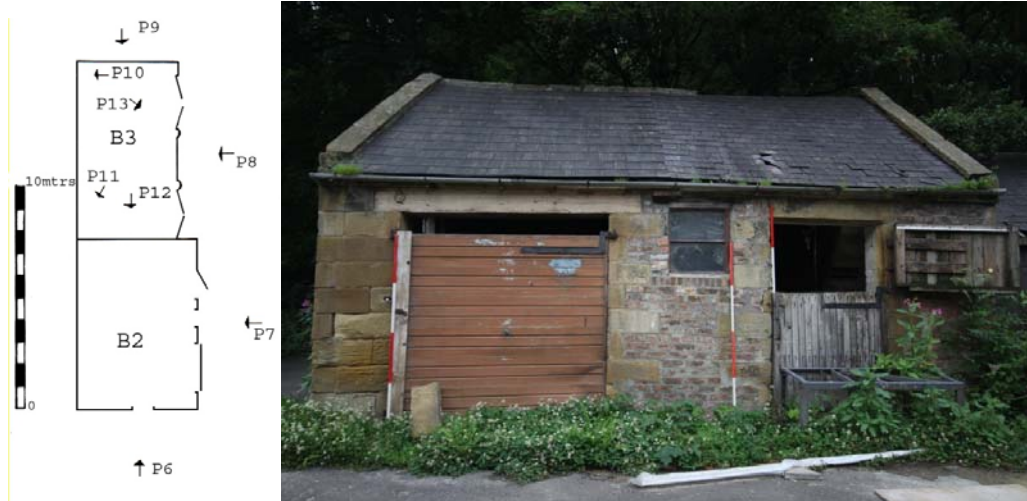
This is a brick and sandstone building that is argued to be contemporary with the other farm buildings. The north side is brick laid in English garden wall bond of three stretches and one header. There are no windows on this side. The west side is brick with a sandstone lintel and sill supporting the only window on the west wall and with quoins on the southern corner. The south side is mostly dressed sandstone measuring 0.68m x 0.25m with two entrances: one for carts on the west and one for animals on the east. The eastern side of the building is brick but is abutted by Building 3, a garage. The building has a pitched slate roof that has been repaired with newer slates on the west side and a sandstone parapet with a plastic rainwater gutter on the south face. The interior of Building 2 was not entered because of the unsafe nature of the structure.

(left) Fig. 5 Plan of Buildings 2 and 3. (right) Pl. 5 Building 2, south face looking north (P7 on plan).

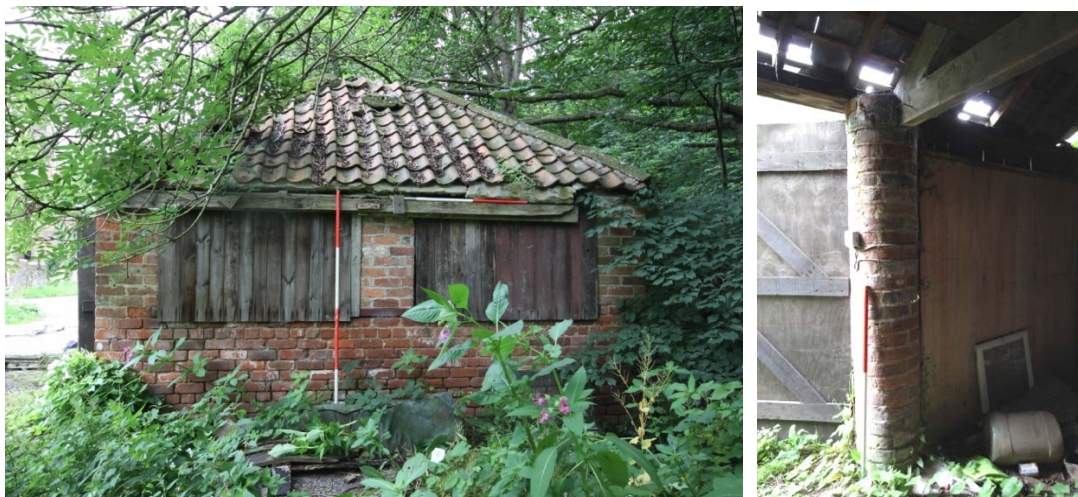
This was a brick building that abuts Building 2 and thus utilises the east wall of Building 2 as the west wall of Building 3. The north wall is brick and is formed by pillars connected by a low wall that is infilled with wooden boards to ceiling height. The east side is built in the same manner (Pl. 6) with bricks laid in English garden wall bond of five stretchers and one header. The south side originally was likely to have been open and was defined by two pillars of rounded bricks forming three openings (Pl. 7). The building has a hipped roof with pantiles on the north and east sides and slates on the south. The building was completely open inside with an earth floor, and there were no other features. This building may have been used as a cart shed.

(left) Pl. 6 Building 3 eastern facade looking west. (right) Pl. 7 Detail of rounded bricks on south side on plan (Fig. 5, Pl. 3).

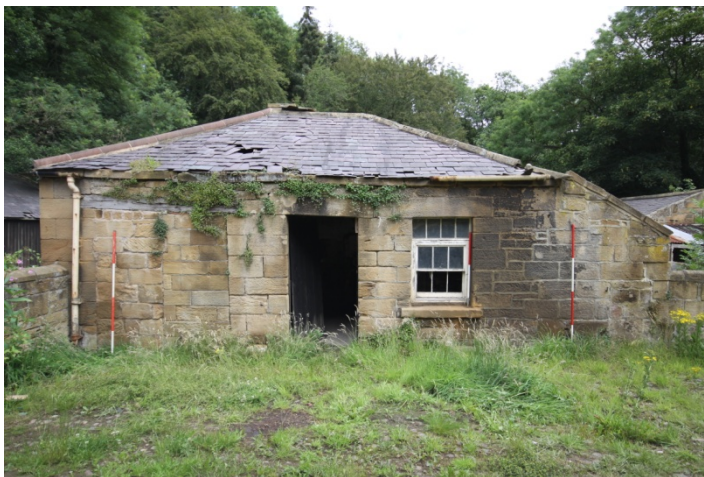
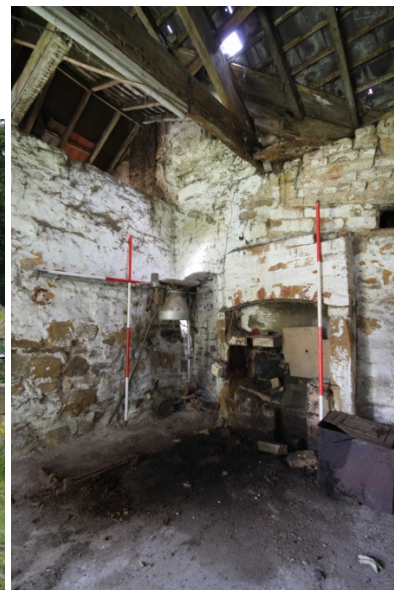
Building 4 and Building 5 are recorded separately, as discussed earlier. Building 4 was a sandstone building that formed part of the main core of a U-shaped farm layout to the east of the house and mill. The building, like all others in this central core, is a single storey sandstone structure with a hipped slate roof. This building, it will be argued, dates between 1856 and 1893 and has been adapted, possibly after World War II. The building has two rooms, described separately. The building will be described from the north, east, south and west followed by the interiors. The north side of the building was made from dressed sandstone with a herringbone-shaped pattern with quoins on the corners. The door into Building 4 is later. It is recognisably cutting into the sandstone and had a timber lintel above the door, whilst the original openings on the building are stone. The east side is formed by the wall of Building 5. Building 4 has been extended further south to create two pig sties and a small walled enclosure for pigs. This is made from larger sandstone blocks measuring 0.60m x 0.22m. The west side of the building faces the mill and house. The sandstone blocks in this phase of the building measured 0.44m x 0.18m. This side of the building had the most alterations with one blocked door, possibly for carts, and the extension of a wall on the south side to create the pig sty (Pl. 8, the 2m ranging rods are sited at the location of the alterations). Inside the building there were two rooms: the southern with a fireplace and remains of machinery associated with a dairy (Pl. 9) and the northern possibly a former cart shed now has a concrete floor and walls plastered up to a height of 1.50m. This may have been used to store milk in a cool environment.

(left) Pl. 8 Western side of Building 4, (P15 on Fig. 6).(right) Pl. 9 Interior of southern room (P21, Fig. 6).

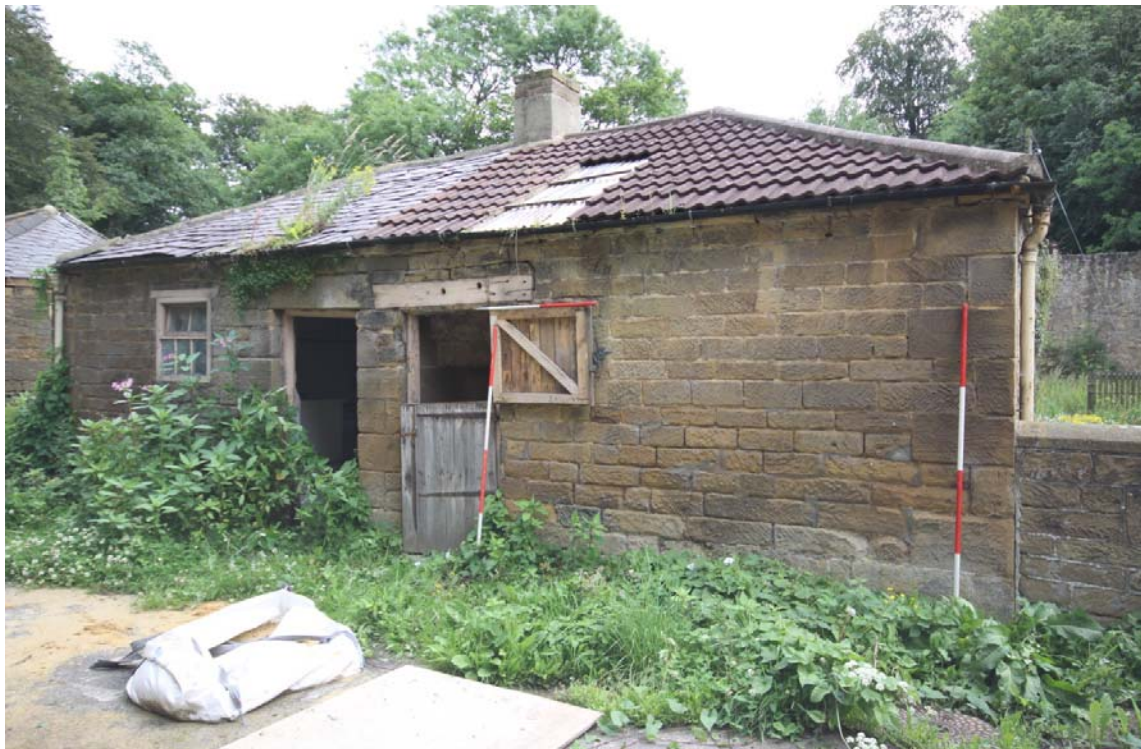
Pl. 10 Buildings 4 and 5, north elevation looking south, (P14 on Fig. 6).

This building abuts Building 4 and they share the same north wall. This was clearly built in one phase but divided later. The window in this wall may have been added later because the lintel is timber rather than stone and appears to have been cut into the sandstone rather than an integral part from the original construction. The east side is made of plain sandstone blocks with no windows or doors. The south side is a sandstone wall with sandstone blocks measuring 0.44m x 0.18m that have a herringbone pattern. The building is still equipped as a milking parlour with plaster and whitewashed walls, a concrete floor and metal pipes feeding into Building 4.

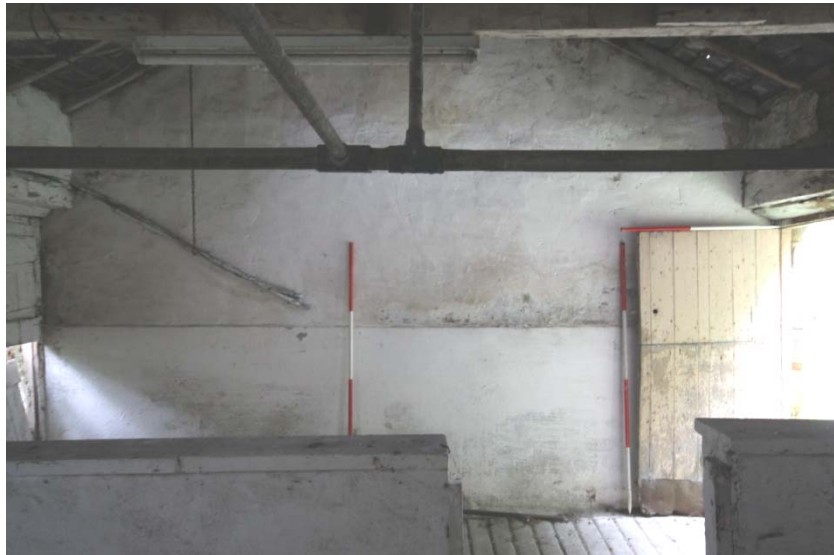
Pl. 11 Interior of milking parlour (P27 on Fig. 6).

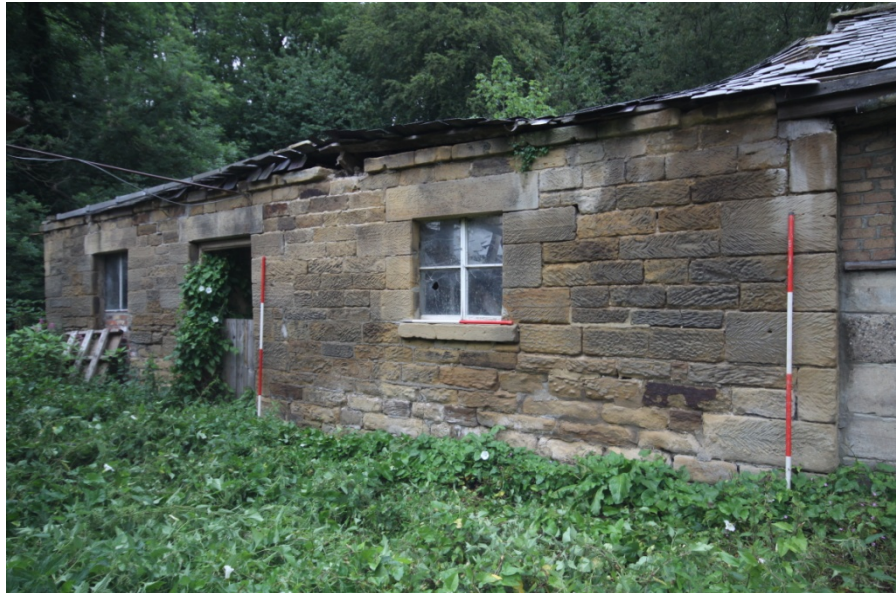
This is a sandstone building on the east side of the site. The building is in poor condition and the roof had collapsed in the cowshed and access was not attempted. The building will be described from the exterior. Building 6a in the south-east comprises the only internal photograph. The north side of the building has sandstone cut to blocks measuring 0.60m x 0.20m, and has larger quoins on the corners and one window with a sandstone lintel and sill. The east side is one long wall of similar sized sandstone blocks, measuring in total 16.8m with one small window at the southern end of the wall. The southern side is a continuous wall 12m long, again with a single window. The western face of the building is shorter and shows the original length of the building to be 10.90m where the quoins are visible for the corner. It is suggested the western side was open from this point but later incorporated into the building (marked on Fig. 7 as SE). The western side of the building is made of cut pieces of sandstone measuring 0.60m x 0.20m with one window and two doors; the northernmost door was blocked. As stated earlier, Building 6 was not entered because the roof had collapsed. A later phase of the development created a small stable by enclosing the SE and building on the southern wall. So, what had formerly been a cowshed and open yard to the south was adapted to include a stable and pig sties. These are discussed below. The south-east corner of the building (SE on Fig. 7) has putlock holes set into the north and south walls suggesting that if this had an earlier roof it was lower than the existing structure. Inside, the building has whitewashed walls and a wooden feed trough on the west where the door had been created by enclosing the wider opening using breeze blocks.

Pl. 12 The western side of Building 6 (P32 on Fig. 7).

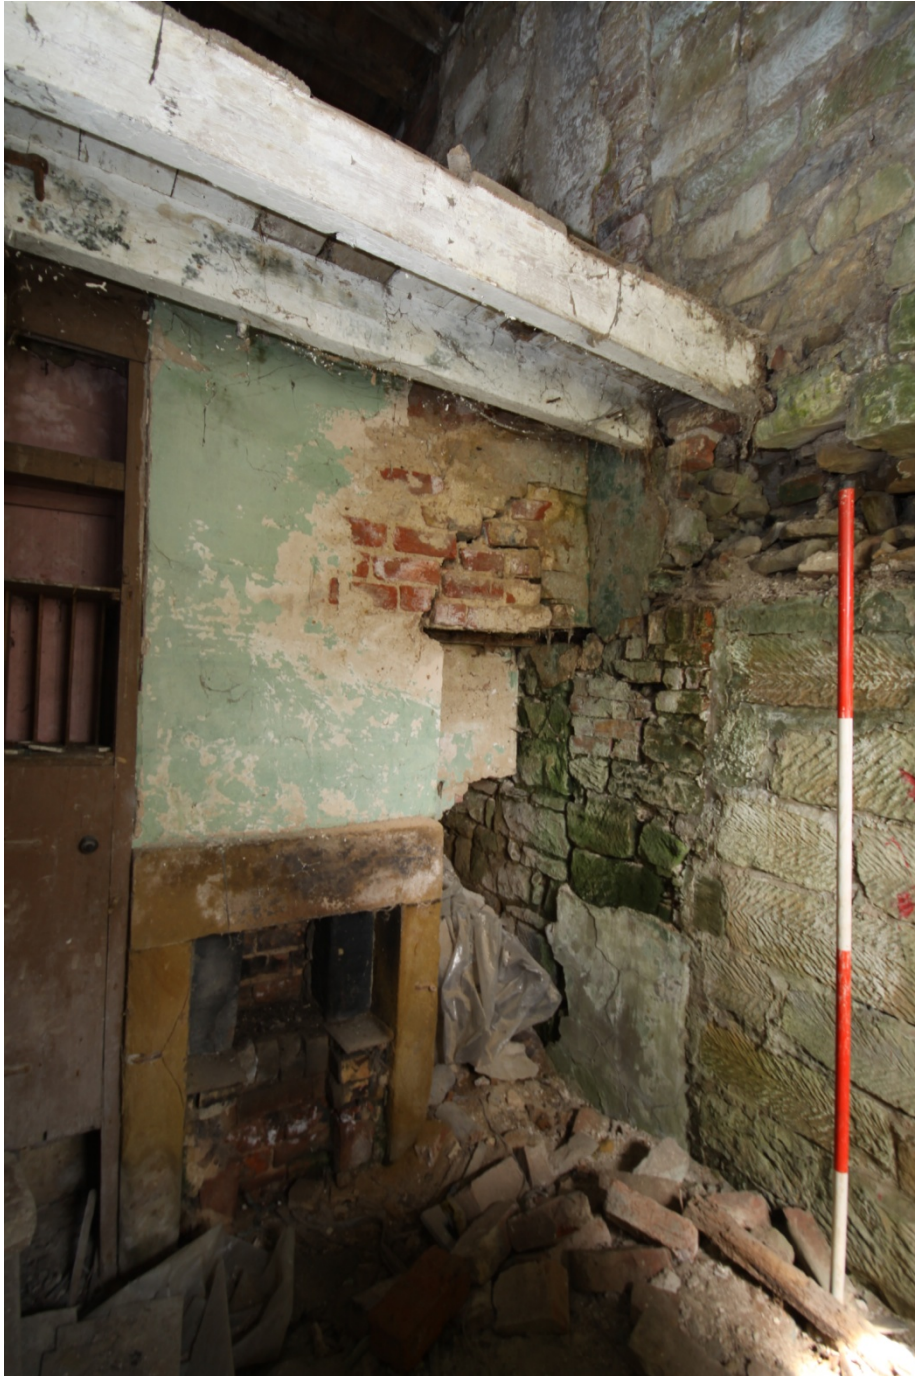
There are two rooms within the mill, both are exceedingly unstable at present. The eastern room is full of agricultural equipment, but there are no surviving mill fittings. In the western room there is a fireplace, cupboard and a plaque from Drake & Gorham who were electronic engineers and supplied the equipment to generate electricity from the mill. The floorboards above were cut to remove the millstones from the site to Tocketts Mill (John Harrison, pers. comm.): the stones were not originally sited in this position but had been moved after the site was destroyed in 1942.

Pl. 14 Interior of Skelton Mill, western room.
